**Flood Control Project Maintenance  
Levee Inspections**

**Fall 2019 Levee Maintenance Deficiency Summary Report**

**Sacramento River Basin**

**Reclamation District No. 2035 Conaway**

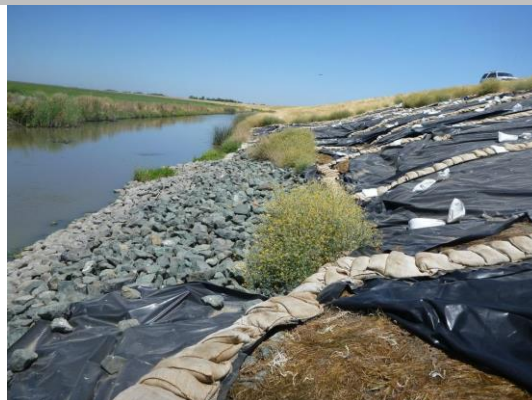
Photo 3 of 4 : LEVAL\_FA\_2019\_195\_1603.jpg

LM Start	6.35	Rating **	A/W	Issue No.	31 (cont)
LM End	6.38	Issue Type +	Ma	Location *	LS
Category	Supplemental			GPS Latitude/Longitude	
				Start	End
Item	2017 Storm Damage			38.592840 °	38.592390 °
				-121.631340 °	-121.631320 °
DWR ID	RD 2035-08				
Comment Code					
Inspector Comment					
Levee Evaluation Comments					
Description:					
Site ID No:195					
Site Designation:RD 2035-08					
Repair Type: Erosion					
Rating:Critical					
Field Date:7/13/2017					
Notes: long longitudinal cracks on the crown. Scheduled for repair in 2020.
